COMPREHENSIVE MANAGEMENT PLAN for LAKE AGAWAM

June 2009

Comprehensive Management Plan for Lake Agawam

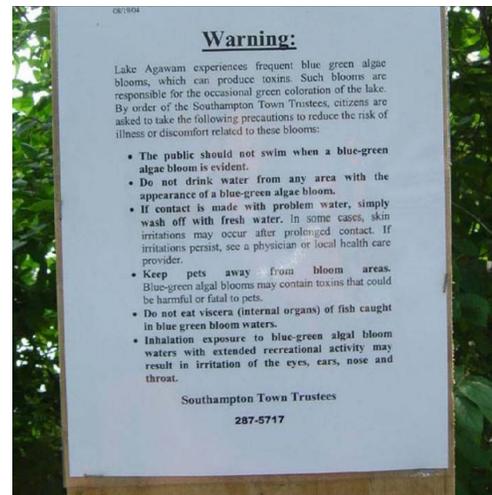
Photo: Chris Gobler, MSRC

As toxic blue green algae blooms are associated with stagnant, eutrophic waters, the following two approaches should be tested as methods for reducing the occurrence and risk of toxic cyanobacteria blooms in afflicted lake systems (**Gobler, 2007**):
